Manhole Inspection Summary

Manhole # S37AA_039MH

Insp Date: **12/2/08 11:27 AM**

Location Address: **717 forrest st**

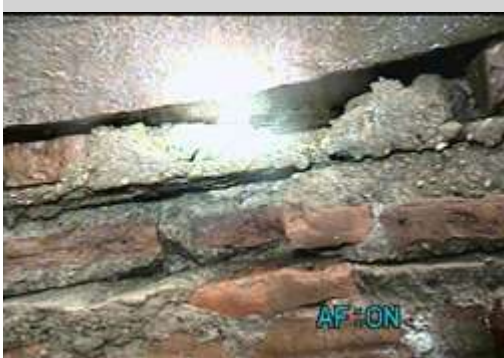
Defect 2

Condition: ☐ Sound ☒ **Cracked** ☐ Root Intrusion ☒ **Loose Brick** ☐ Deteriorated

frame adj cracked, loose bricks

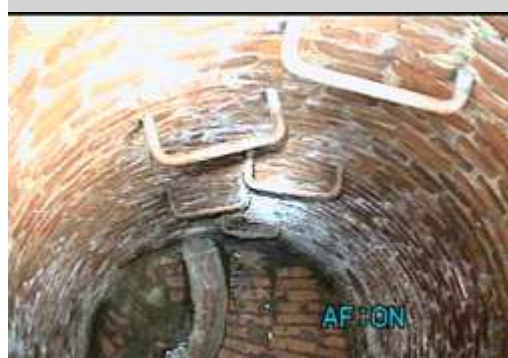
Defect 1

Steps Count: **5** Missing: **0** ☒ **Corroded**

cor. steps

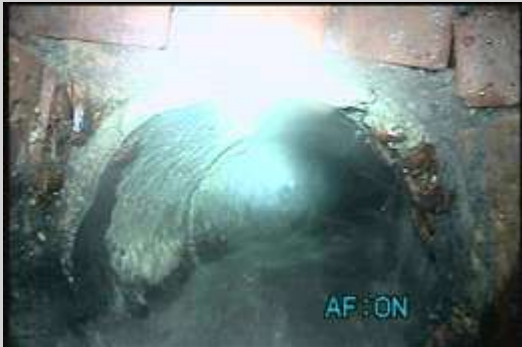
12 O'Clock Outflow

8 in. Circular Gravity Sewer
Pipe Out @ 12 O'Clock

Deposits: ☒ None ☐ Mud ☐ Sludge ☐ Debris ☐ Grease

Infiltration: **None** Pipe Seal Cond: **Unknown**

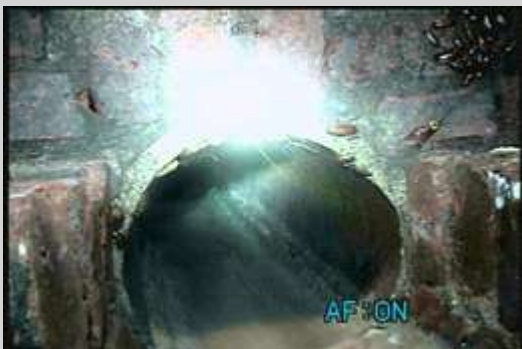
3 O'Clock Inflow

8 in. Circular Gravity Sewer
Pipe In @ 3 O'Clock

Deposits: ☒ None ☐ Mud ☐ Sludge ☐ Debris ☐ Grease

Infiltration: **None** Pipe Seal Cond: **Unknown**
